# Technical Announcement

Delta Electronics, Inc. IABG

Firmware update release for the ASDA-B3 series products.

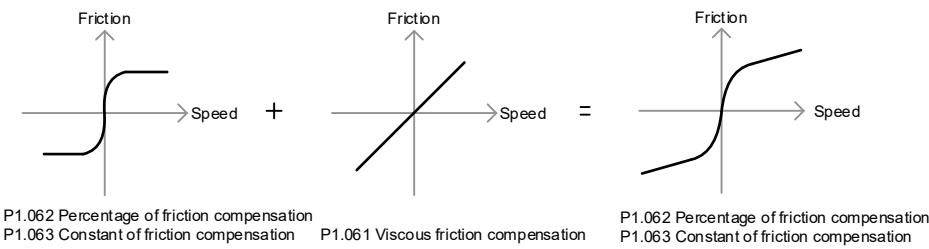
Because kinetic friction corresponds with the speed, you can use this parameter to compensate the motor torque according to the speed to improve the position error during acceleration and deceleration. When P1.062 = 0, this parameter is invalid.

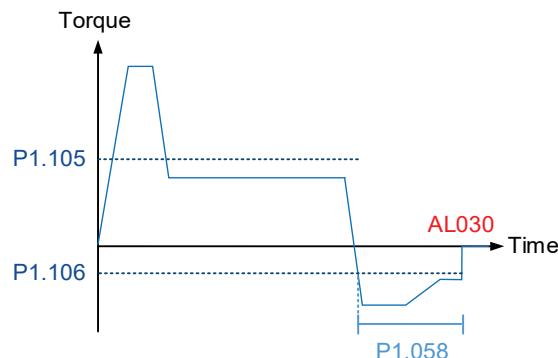
When Motor hard stop 2 is enabled (P2.112.bit 8 = 1), the settings of torque percentage (P1.057) and level offset (P1.060) for Motor hard stop are invalid. During motor operation, if the motor current is higher than this protection setting value and continues in this state exceeding the protection time (P1.058), AL030 will be triggered.

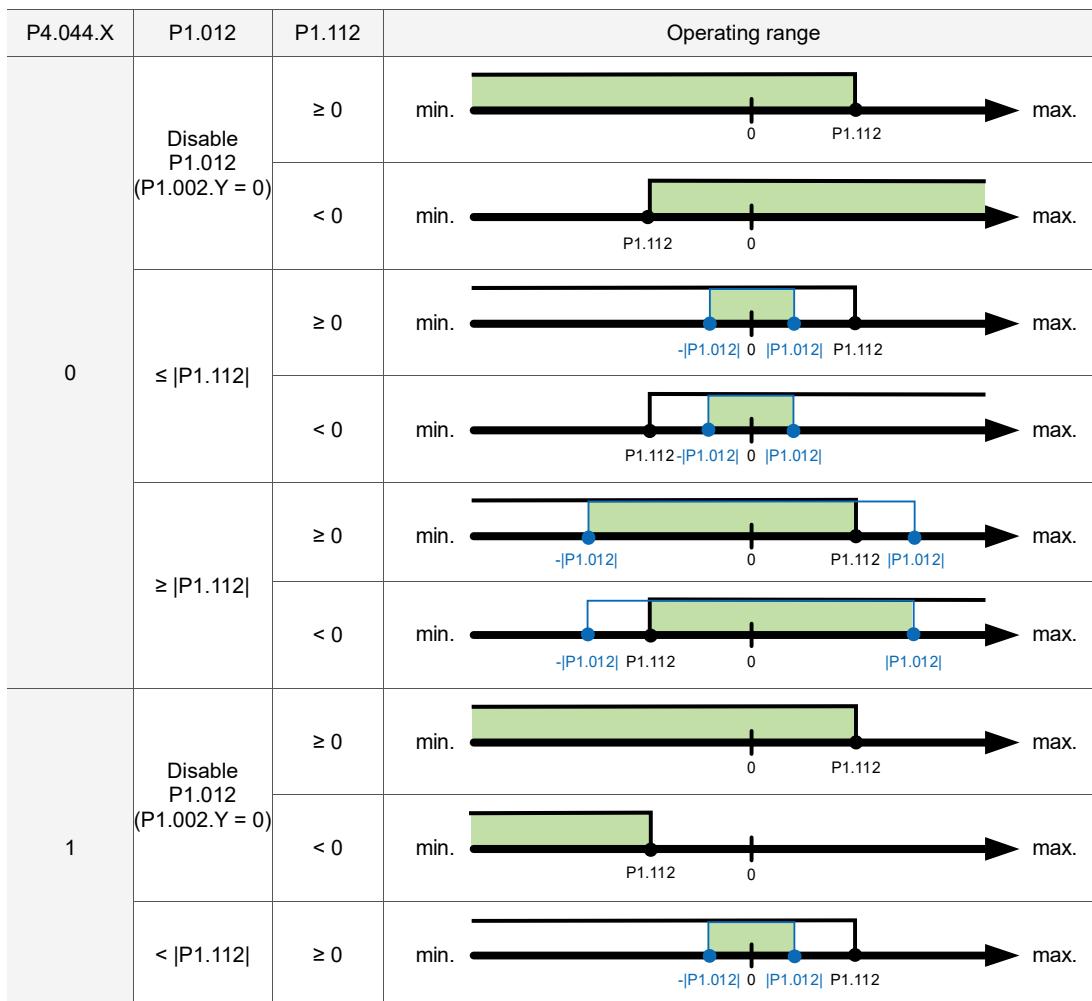
This parameter limits the torque of the motor. The area with the background color is the torque limit area.

P4.044 is applicable to external analog commands and internal torque limits (P1.012 - P1.014). The following diagrams are illustrated based on P1.012 and you can set P4.044 according to the requirements.
